Subject: Stage 1 Road Safety Audit

Document title: Deal Farm, Bressingham

Subtitle: Stage 1 Road Safety Audit

Project name: Deal Farm - Stage 1 Road Safety Audit

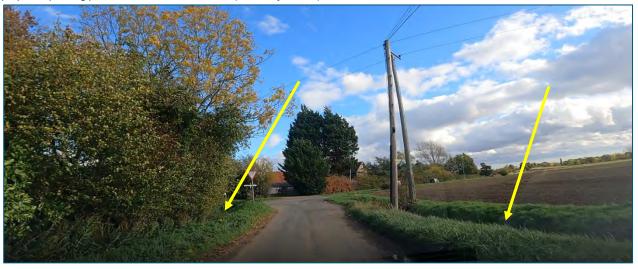
**Summary:** Proximity of proposed passing places to drainage ditches could result in vehicles inadvertently leaving the carriageway with the potential for injury.

**Description:** Some of the passing places appear to be located immediately adjacent to deep drainage ditches. Vehicles manoeuvring into/ out of the passing places could inadvertently leave the carriageway to the nearside, sliding into the ditches or entering the adjacent fields, resulting in the potential for injuries to vehicle occupants.

Photograph 3 - Image of Kenninghall Road looking east towards Common Road, showing deep drainage ditches adjacent to proposed passing places at Locations 33 and 35 (shown by arrows)

The locations of the passing places should be located to reduce the potential for vehicles to enter ditches whilst entering/ leaving the passing places.

| Paragraph<br>No. in<br>Safety Audit<br>Report | Problem<br>Accepted<br>(yes/no) | Recommended<br>Measure<br>accepted<br>(yes/no) | Description / alternative measure |
|---|---|--|--|
| A1.2.2 | No | | A kerb is proposed at the edge of the passing bay. The kerb will keep the vehicles safe and away of the ditch. A short pipe culvert will be proposed for sections where the passing bay is on top of existing ditch. The latter to be reviewed at detailed design stage with the topographical survey. |

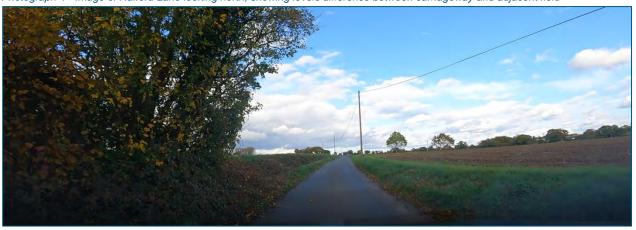
**Summary:** Vehicles overhanging the main carriageway could lead to side swipe collisions with passing traffic leading to the potential for damage and secondary collisions elsewhere on the highway.

**Description:** Earth banks are present adjacent to four of the proposed passing places. The presence of these boundary features could restrict the available space to provide a passing place of sufficient width to accommodate a vehicle without overhanging the main carriageway. Vehicles overhanging the main carriageway could lead to swipe collisions with passing traffic resulting in the potential for damage and secondary collisions elsewhere on the highway.

Photograph 4 - Image of Halford Lane looking north, showing levels difference between carriageway and adjacent field

The width of the proposed passing places should be sufficient to accommodate a vehicle fully, without overhanging the adjacent carriageway. Where existing boundary features are unable to be modified to accommodate the passing places, consideration should be given to relocating the passing place.

| Paragraph<br>No. in<br>Safety Audit<br>Report | Problem<br>Accepted<br>(yes/no) | Recommended<br>Measure<br>accepted<br>(yes/no) | Description / alternative measure |
|---|---|--|--|
| A1.2.3 | No | | As shown on the swept path analysis drawings, an oil tanker and a large car can pass side by side. This was prepared on an OS base and to be checked with topographical survey at detailed design stage. |

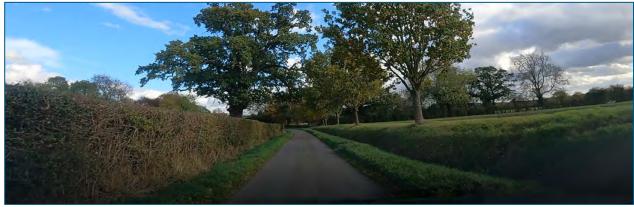
Photograph 5 - Image of The Valley looking east, showing earth bank to the south of the carriageway

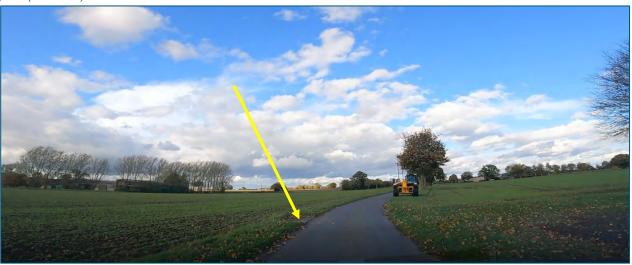
**Summary:** Service chamber covers of incorrect loading specification could collapse due to vehicle overrunning, leading to the potential for vehicle damage and resulting loss of control collisions.

**Description:** A service chamber cover is currently sited within the western verge of Halford Lane within the extents of a proposed passing place (Location 6). The proposals would result in the existing chamber cover being subject to overrunning by vehicular traffic. If the loading properties of the cover is not sufficient, it could become damaged or collapse, leading to vehicle damage and the potential for loss of control collisions.

Photograph 6 - Image of Halford Lane looking north, showing service chamber cover within the extents of the proposed passing place (Location 6)

Where service chamber covers previously sited within the verge are to be exposed to vehicle movements, these should be of sufficient standard to accommodate the appropriate vehicle loadings.

| Paragraph<br>No. in<br>Safety Audit<br>Report | Problem<br>Accepted<br>(yes/no) | Recommended<br>Measure<br>accepted<br>(yes/no) | Description / alternative measure |
|---|---|--|--|
| A2.1.1 | Yes | Yes | Existing chamber covers to be upgraded, if need, to accommodate vehicular loading. To be addressed at detailed design stage. |

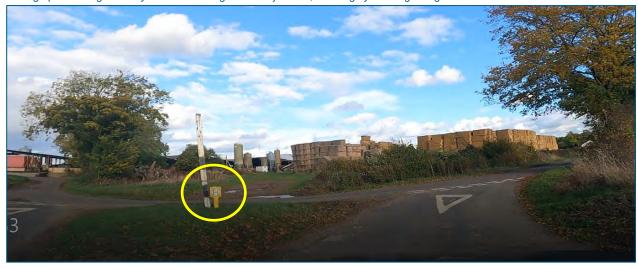
**Summary:** Reduced conspicuity of the location of a fire hydrant could lead to high severity injuries or significant damage to property in an emergency situation.

**Description:** A fire hydrant marker is present on the grassed island at the junction of Lady's Lane and Kenninghall Road. Drawing PC4115-RHD-ZZ-ZZ-DR-D-0008 indicates that the island would be removed in order to accommodate HGV movements. Information provided to the Audit Team does not provide details in relation to the relocation of the hydrant marker or whether it may be necessary to relocate access to the hydrant itself. Failure to relocate the sign to a suitable location could result in delays in obtaining access to the hydrant during an emergency situation, leading to the potential for high severity injuries or significant damage to property.

Photograph 7 - Image of Lady's Lane/ Kenninghall Road junction, showing hydrant sign on grassed island

The Designers should liaise with the relevant Water Officer at Norfolk County Council in relation to the requirement to relocate the fire hydrant marker.

| Paragraph<br>No. in<br>Safety Audit<br>Report | Problem<br>Accepted<br>(yes/no) | Recommended<br>Measure<br>accepted<br>(yes/no) | Description / alternative measure |
|---|---|--|--|
| A2.1.2 | Yes | Yes | At detailed design stage, designer to liaise with the relevant authority for fire hydrant relocation. |
