Proposed AD Plant, Bressingham

Transport Statement Part 2 of 2

Stage 1 Road Safety Audit

Subtitle: Stage 1 Road Safety Audit

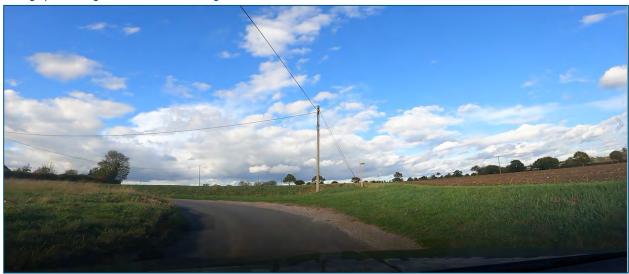
Summary: Collisions with street furniture/ trees could lead to the potential for collapse of the infrastructure, leading to injuries or to subsequent collisions.

Description: The proximity of the passing places (and the reconfiguration of existing junctions) to signs, telegraph poles and trees could lead to collisions with these items as vehicles are manoeuvring into the passing facilities. Collisions with street furniture and trees could result in injuries or to damage to the infrastructure leading to collapse and subsequent collisions.

Photograph 3 - Image of Halford Road looking north towards Location 2

Street furniture within the extents of the proposals should be relocated where possible. If it is not possible to relocate the street furniture or remove trees, the passing places be relocated to reduce the potential for collisions with existing infrastructure.

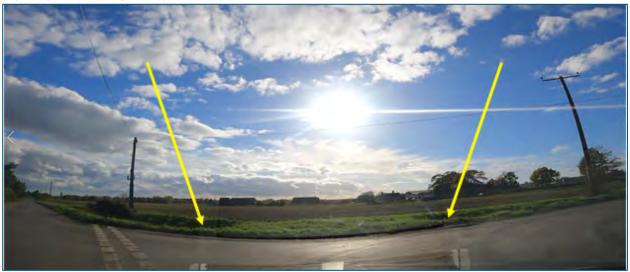
Summary: Proximity of proposed passing places to drainage ditches could result in vehicles inadvertently leaving the carriageway with the potential for injury.

Description: Some of the passing places appear to be located immediately adjacent to deep drainage ditches. Vehicles manoeuvring into/ out of the passing places could inadvertently leave the carriageway to the nearside, sliding into the ditches or entering the adjacent fields, resulting in the potential for injuries to vehicle occupants.

Photograph 4 - Image of Kenninghall Road looking east towards Common Road, showing deep drainage ditches adjacent to proposed junction reconfiguration (Location 24)

Passing places should be located to reduce the potential for vehicles to enter ditches whilst entering/leaving the passing places. Where it is not possible to relocate a passing place or where the reconfiguration of an existing junction is proposed, measures (such as culverting the ditch) to protect road users from entering exposed ditches could be provided.

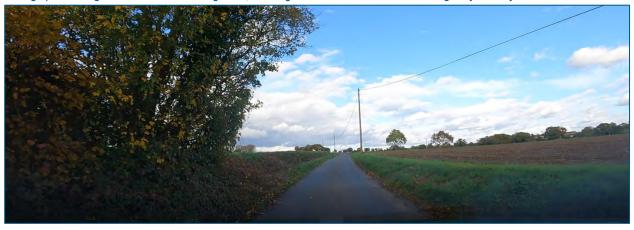
Summary: Vehicles overhanging the main carriageway could lead to side swipe collisions with passing traffic leading to the potential for damage and secondary collisions elsewhere on the highway.

Description: Earth banks are present adjacent to two of the proposed passing places. The presence of these boundary features could restrict the available space to provide a passing place of sufficient width to accommodate a vehicle without overhanging the main carriageway. Vehicles overhanging the main carriageway could lead to swipe collisions with passing traffic resulting in the potential for damage and secondary collisions elsewhere on the highway.

Photograph 5 - Image of Halford Lane looking north, showing levels difference between carriageway and adjacent field

The width of the proposed passing places should be sufficient to accommodate a vehicle fully, without overhanging the adjacent carriageway. Where existing boundary features are unable to be modified to accommodate the passing places, consideration should be given to relocating the passing place.

A1.2.3	Yes	Yes	As shown on the swept path analysis drawings, an oil tanker and a large car can pass side by side. The overhang to be checked with topographical survey at detailed design stage.
A2.1.1	Yes	Yes	A note is added to the drawing, highlighting the location of the fire hydrant. At detailed design stage, designer to liaise with the relevant authority for fire hydrant exact relocation.

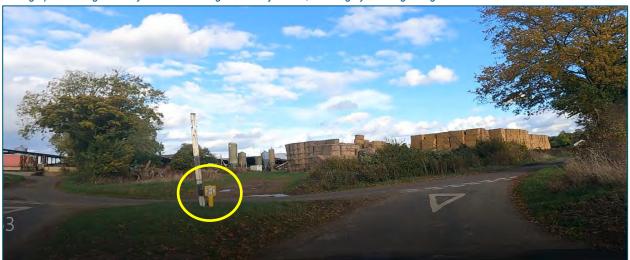
Summary: Reduced conspicuity of the location of a fire hydrant could lead to high severity injuries or significant damage to property in an emergency situation.

Description: A fire hydrant marker is present on the grassed island at the junction of Lady's Lane and Kenninghall Road. Drawing PC4115-RHD-ZZ-ZZ-DR-D-0005 P06 indicates that the island would be removed in order to accommodate HGV movements. Information provided to the Audit Team does not provide details in relation to the relocation of the hydrant marker or whether it may be necessary to relocate access to the hydrant itself. Failure to relocate the sign to a suitable location could result in delays in obtaining access to the hydrant during an emergency situation, leading to the potential for high severity injuries or significant damage to property.

Photograph 6 - Image of Lady's Lane/ Kenninghall Road junction, showing hydrant sign on grassed island

The Designers should liaise with the relevant Water Officer at Norfolk County Council in relation to the requirement to relocate the fire hydrant marker.
