Subject: Stage 1 Road Safety Audit

Document title: Deal Farm, Bressingham

Subtitle: Stage 1 Road Safety Audit

Project name: Deal Farm - Stage 1 Road Safety Audit

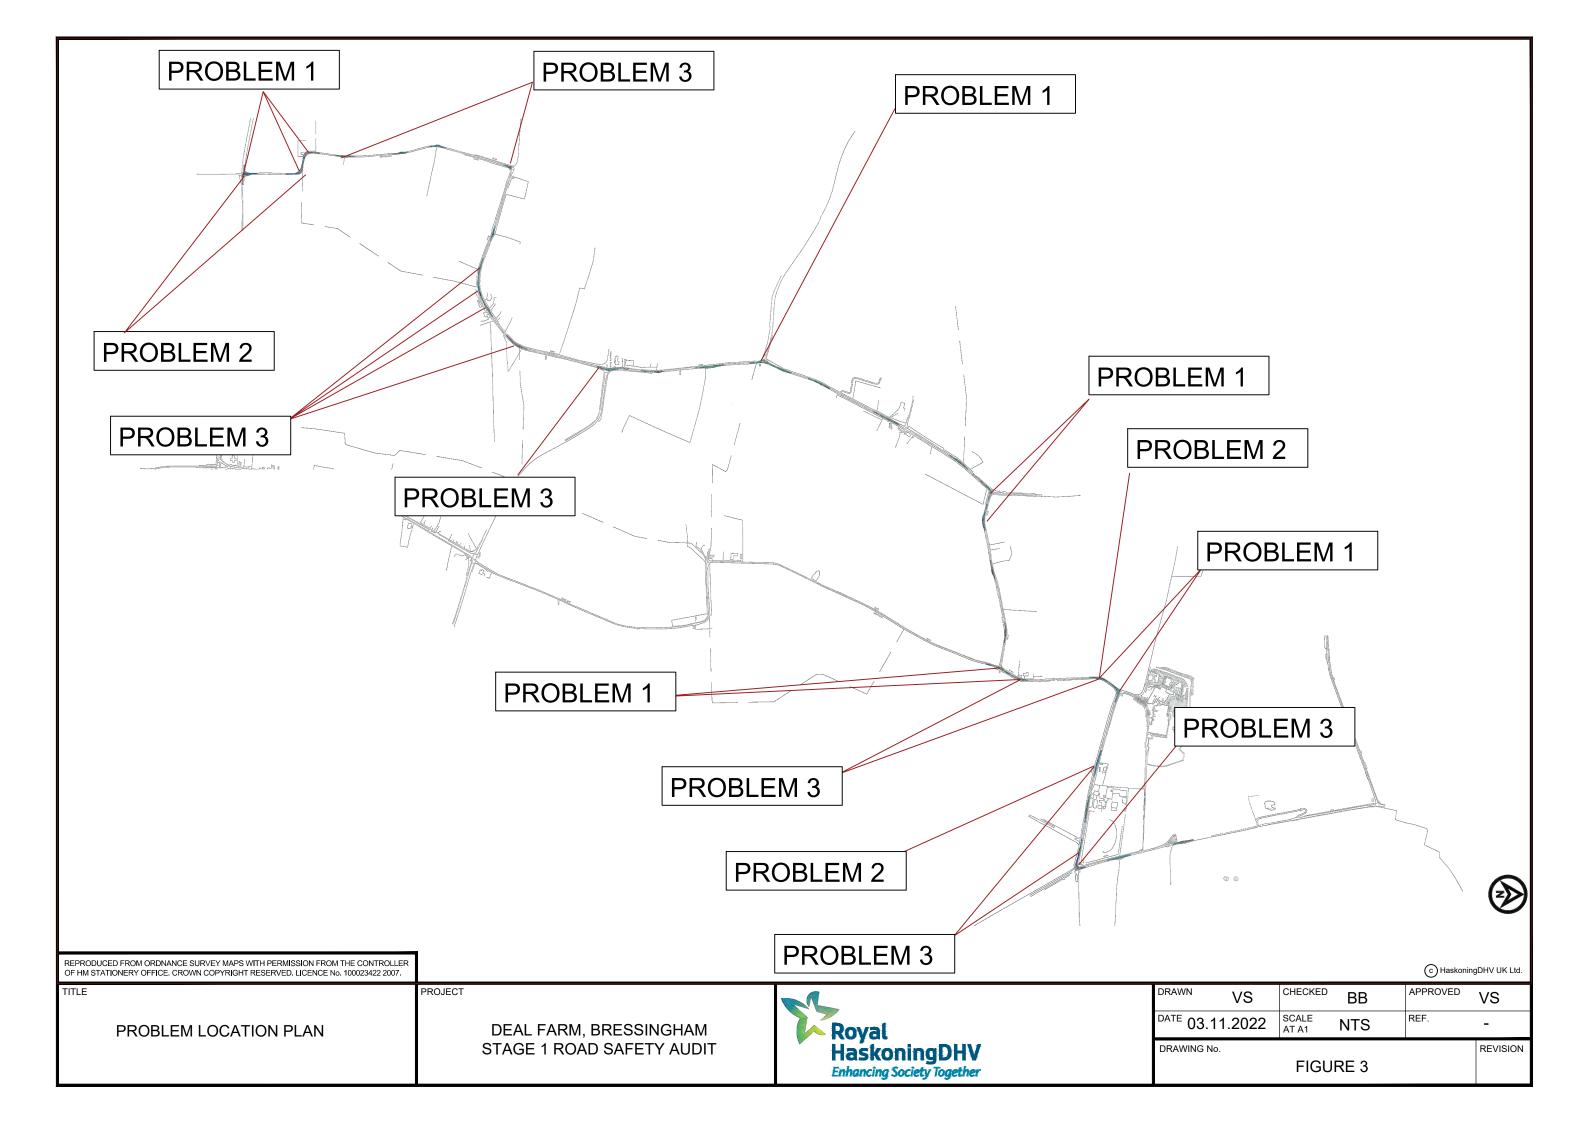
The completed highway works would provide 37 passing places on approximately 4.5 kilometres (km) of existing rural roads. The locations of the passing places have been numbered for ease of identification within this Stage 1 Road Safety Audit. The passing places and identification numbers are shown on **Figure 2** of this report. The locations of any problems identified by the Audit Team are shown on **Figure 3** of this report.
