Proposed AD Plant, Bressingham

Transport Statement Part 2 of 2

Stage 1 Road Safety Audit

Subtitle: Stage 1 Road Safety Audit

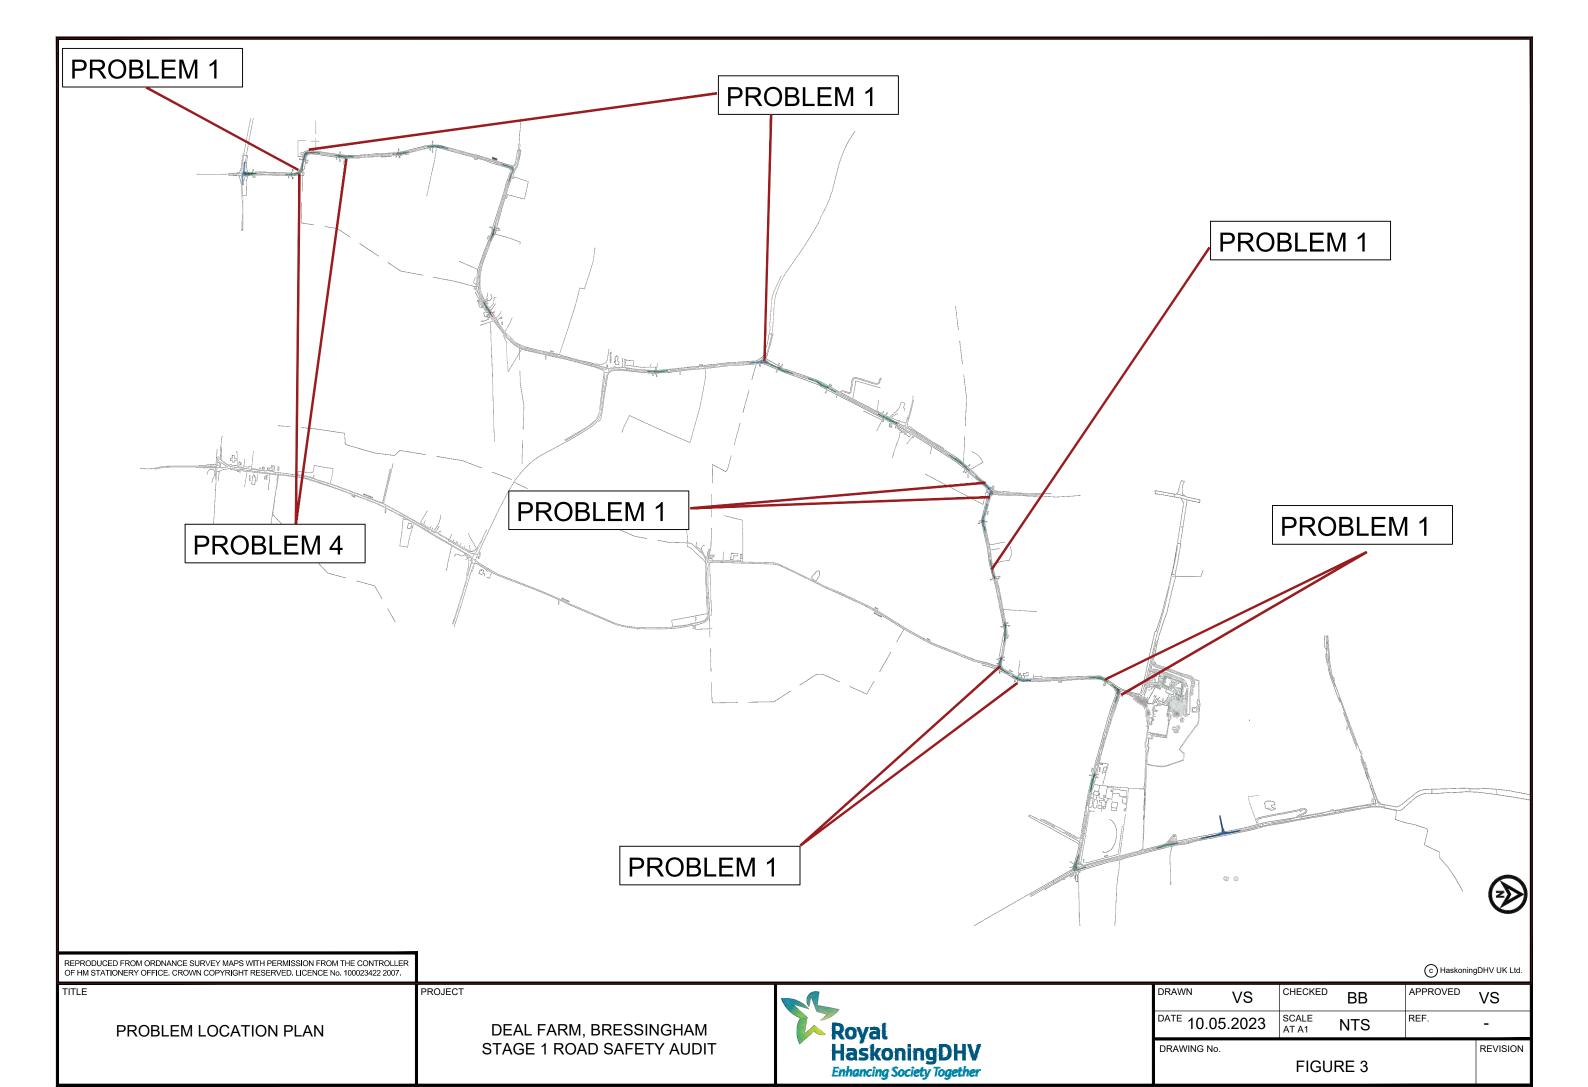
Figure 3 – Problem Location Plan

A similar scheme was subject to a Stage 1 Road Safety Audit in October 2022. The revised scheme would provide 25 no. passing places/ junction modifications on approximately 4.5 kilometres (km) of existing rural roads. The locations of the passing places have been numbered for ease of identification within this Stage 1 Road Safety Audit. The passing places and identification numbers are shown on **Figure 2** of this report. The locations of any problems identified by the Audit Team are shown on **Figure 3** of this report.
